The Amazon (1863) Shipwreck Project

25 November - 5 December 2018

January 2019

Project Report

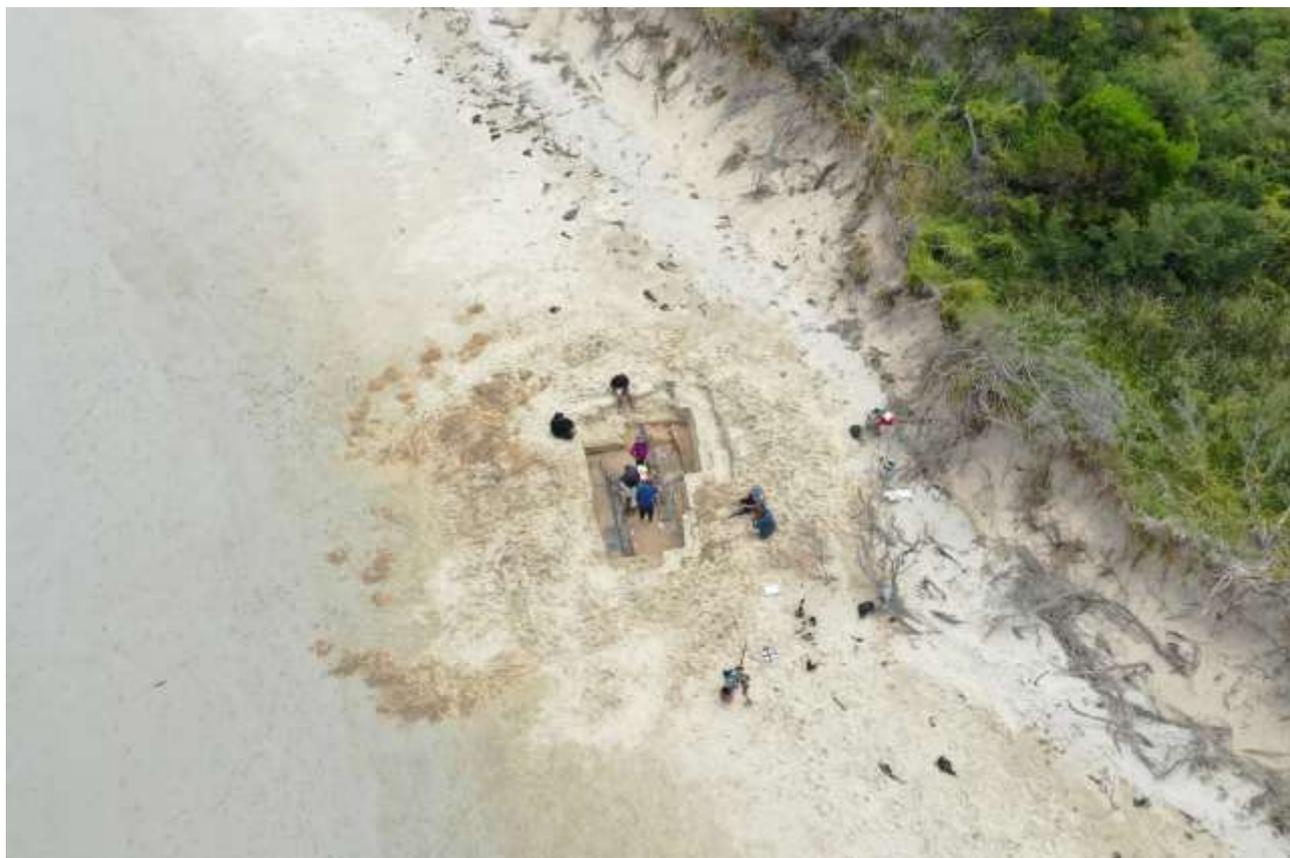
Figure 1: Aerial image of the *Amazon* excavation — Site B.

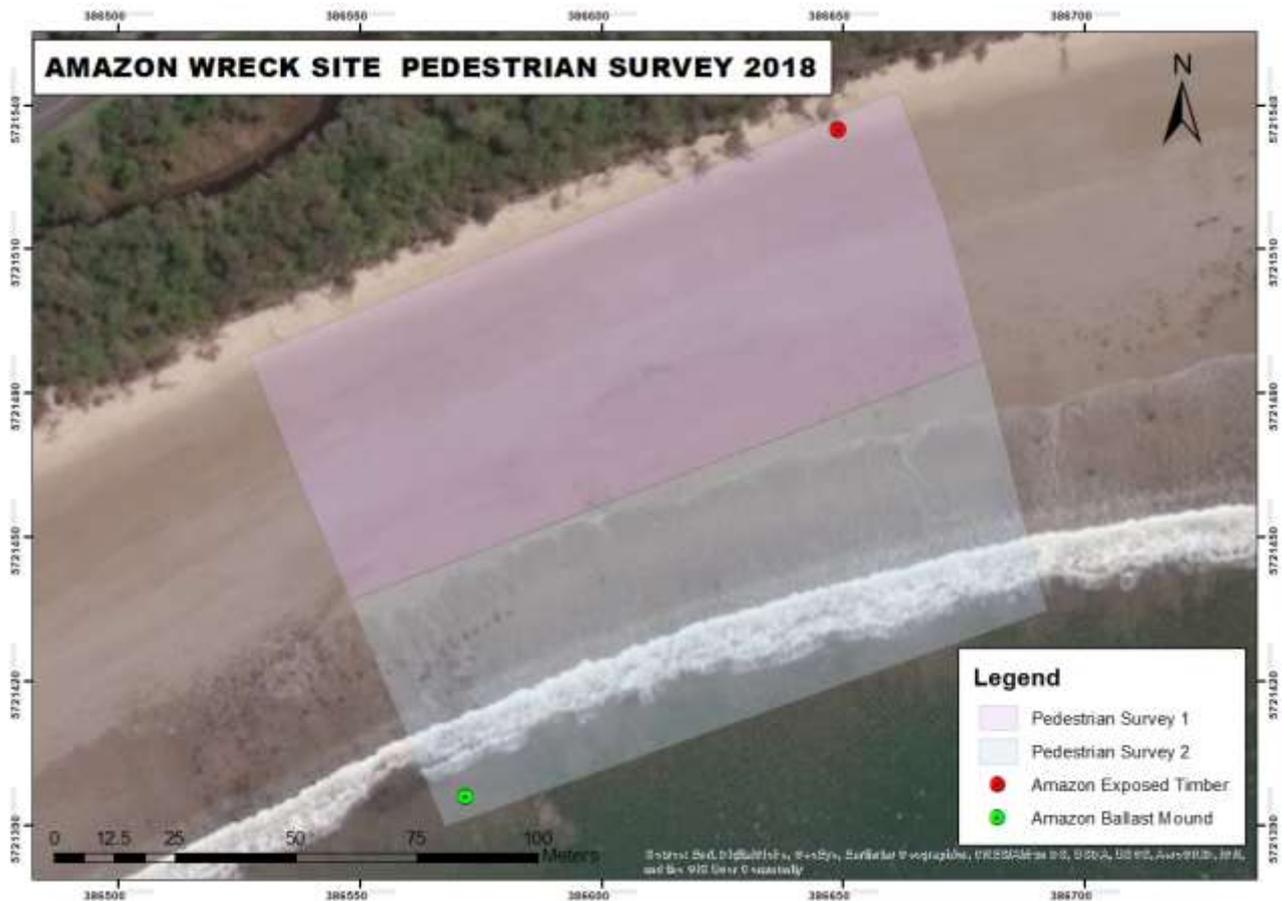
Figure 7: Extent of walking visual survey.

Each team member walked transects approximately three metres apart, and in the direction from the beach head towards the water line (**Figure 6**). With all 11 members, the line moved westward from the exposed timber 150 metres along the beach (in line with the shore). Once this was completed, the group extended the survey an additional 33 metres into the water line. Altogether, the line survey covered 4,900 square metres with the initial 150m length represented in pink and the additional 33m tidal zone survey area represented in white (**Figure 7**). As the group moved along, they flagged objects that they deemed as of potential cultural significance. Several artefacts were located including glass and iron fragments — while the position of these items was recorded, they were deemed modern or too minor to be of relevance (**Figure 5** and **Table 1**).

The final transit line — deepest into the water — located the main wreck site in the southwest corner of the survey area. At this time, we took a simple length measurement of the site (28.5m) and a GPS point (Figure 8). Although the lack of visibility limited our understanding of the overall site remains (and unexpected depth of the site even at low tide) — students could identify ballast stones and wooden frames on the site.

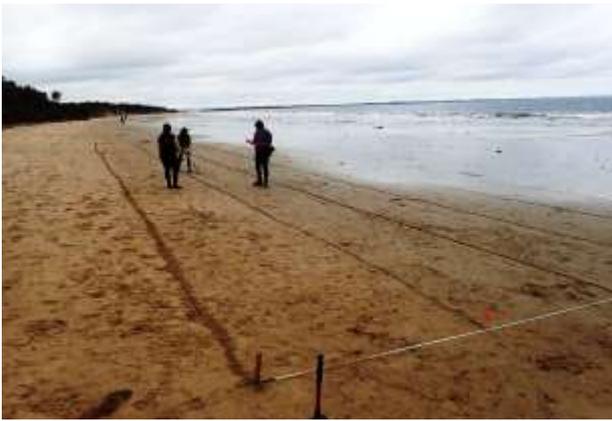
Figure 9: Metal detector survey and grid

The initial survey area measured to about 112 metres (West) x 32 metres (South). The transect was extended 30 metres to the east and 18 metres towards the waterline. The total survey area was 142 metres x 50 metres. Two-meter transect lines were drawn from beach head to the waterline from the 0-metre mark to the 50-metre mark. The metal detecting survey was carried out by sweeping the metal detector roughly 1-metre on each side as close to the ground as possible without hitting the sand along every transect line (**Figure 9**). Flags were used to mark the locations where the metal detectors encountered anomalies. Anomalies were double checked with the other metal detector to verify the findings. GPS points of the anomalies were taken using GPS equipment. They were then dug up until the groundwater level by hand or trowels to investigate each anomaly (**Figures 10 and 11**). Material excavated from the anomalies and the area where the anomalies were found were photographed and measured (**Table 2**).

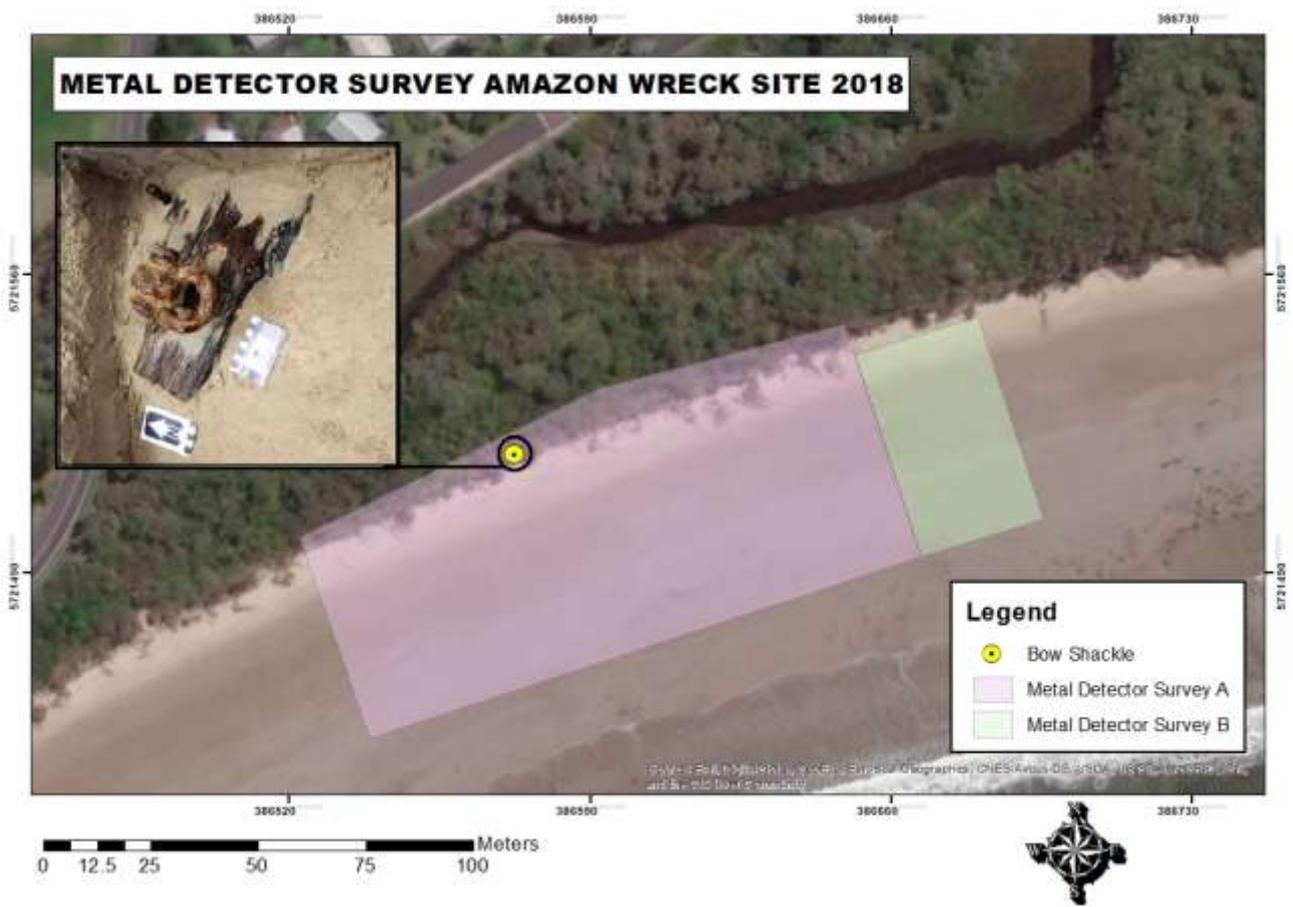
Figure 11: Extent of metal detector survey and main anomaly
 Larger insert shows the ferrous d-shackle located during the survey
 Credit: J. Leach and M. Khoiru

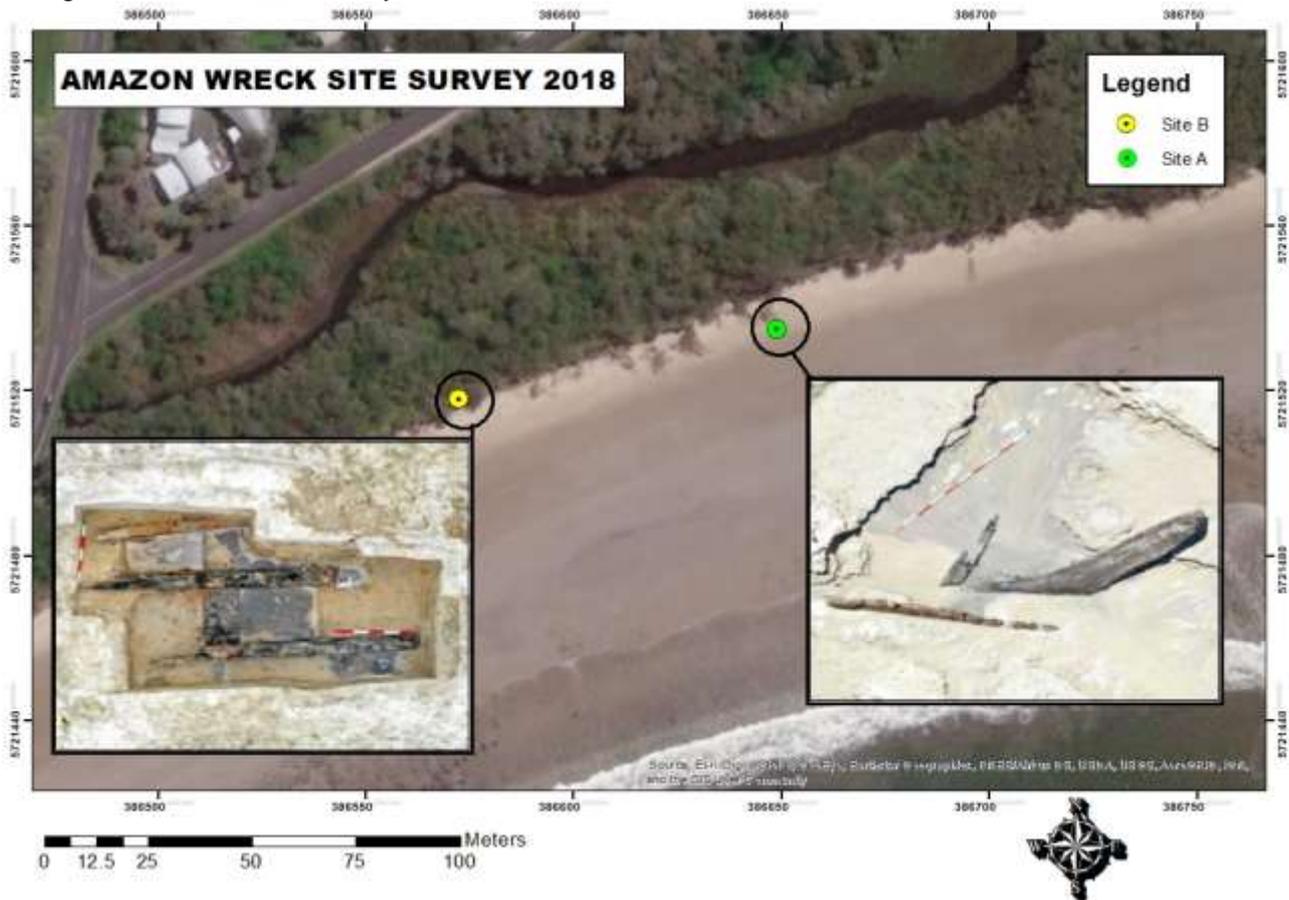
Figure 12: Location of excavation sites

Site A and Site B in comparison to each other.

Two separate sites were excavated over a 3-day period at the end of the project (**Figure 12**). Site A encompassed the visible section on shore—potentially the bow—and Site B was the D-shackle located

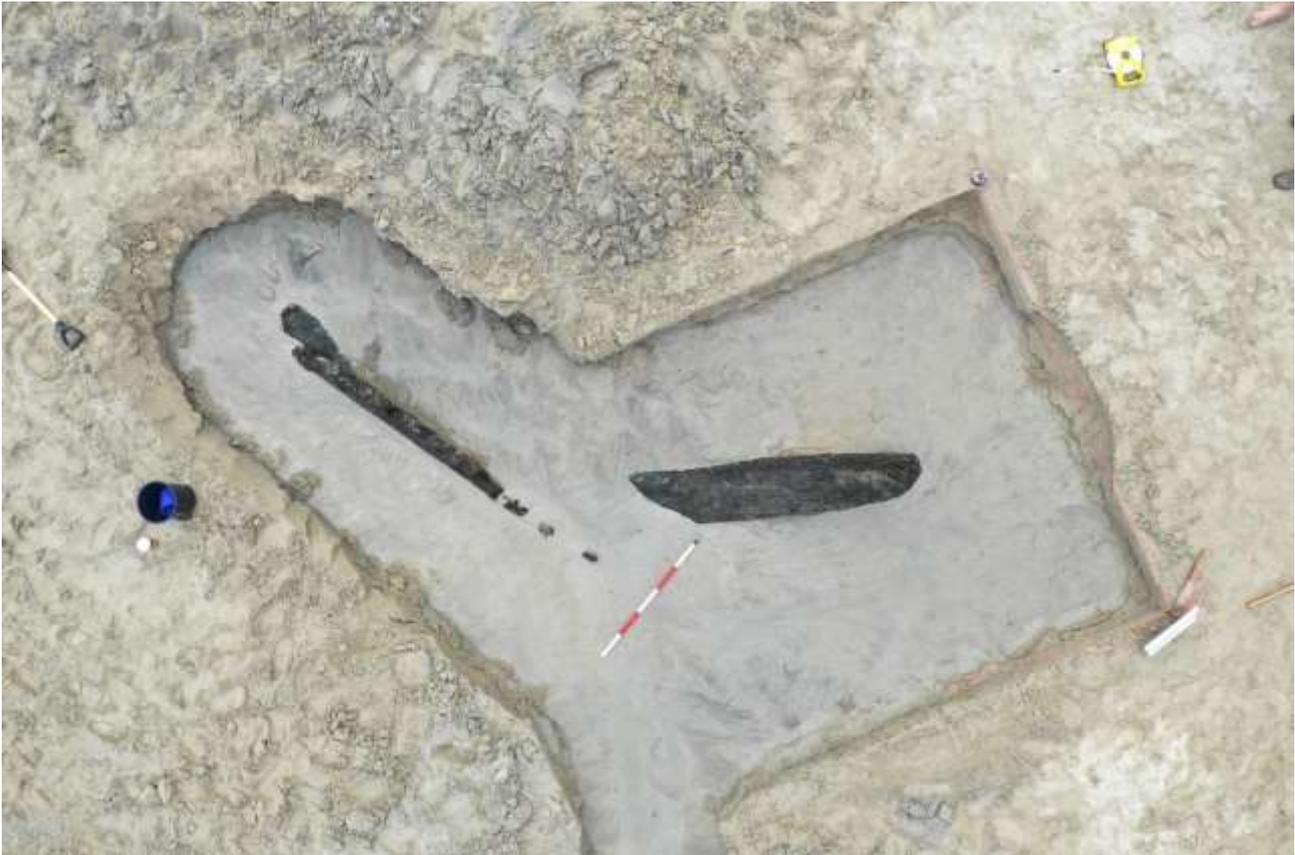
Figure 13: Aerial image of Site A—end of context day 1

Note: the original square grid and then adapted excavation method to follow the timber structure.

Excavation of Site A began with a 3m-by-4m area to a depth of approximately 700mm on the northern and western boundaries. The excavation revealed ship timbers that were interpreted as a section of deadwood, hull planking and framing. After the initial trench was uncovered, the timber features to the southwest (**Figures 13–15**) were uncovered. At this point the excavation approach changed as the tide was on its way back in, and knowledge of this site revealed that this area had uncovered extensively during the past winter season. Consequently, maintaining an exact excavation grid square was not necessary, instead, it was most important as much as possible of the wooden structure could be uncovered and recorded—hence the oblong shape of the southern end of the trench.

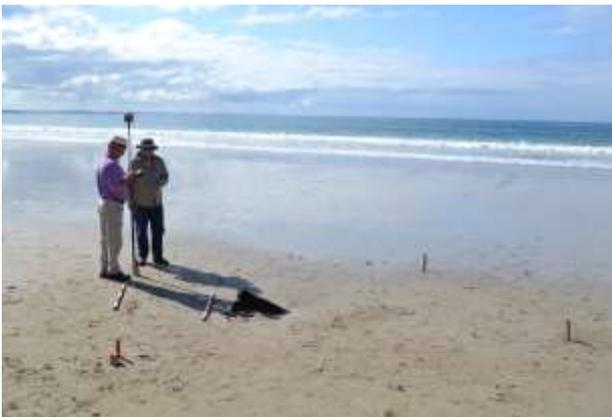
Figure 14: Geospatial recording Site A—pre-excavation

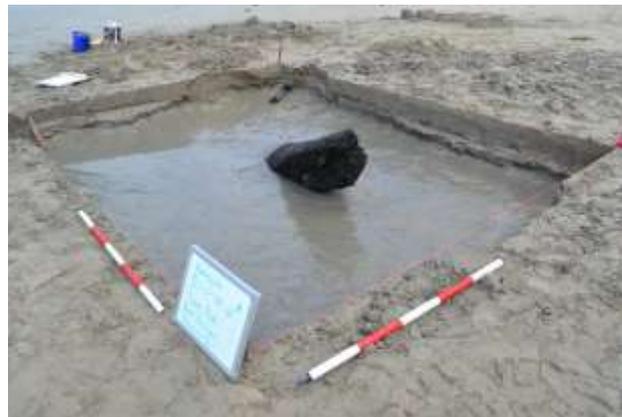
Figure 15: Site A—grid excavation process

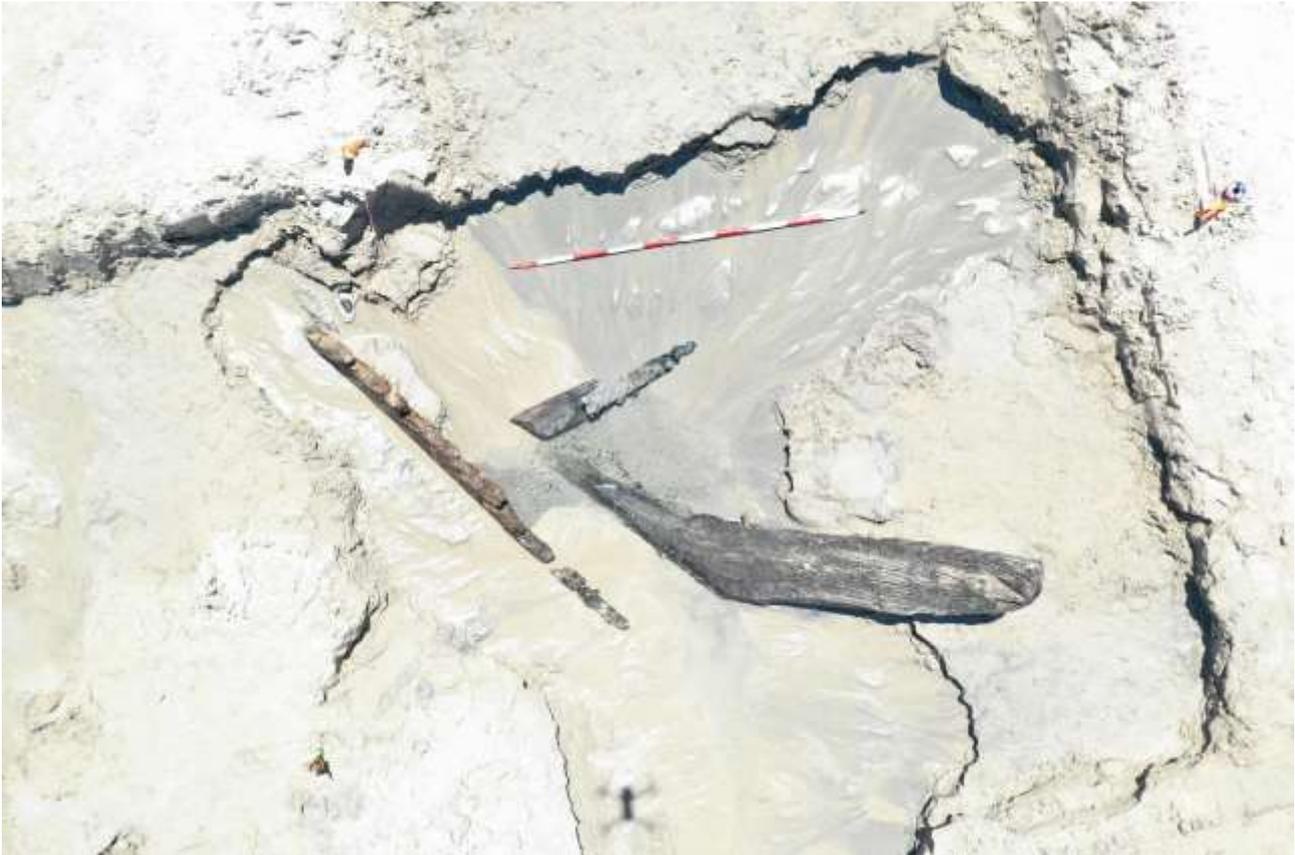
Figure 16: Aerial image of Site A—end of context day 2

Note: extended trenches and new features visible.

On the second day, two further 3m x 4m grids were excavated to the north and the west of the original grid (**Figure 16**). Water seepage was a constant problem during the excavation as Wreck Creek ran parallel to the shore directly behind the site. Consequently, water drains were dug out and maintained through the day to allow continual seepage of water out of the trench. Despite excavating approximately 200mm deeper than the previous day, the water table level could not be dug out any further with manual tools (a water dredge would be required in the future). Unfortunately, we could not expose the connecting point between the deadwood and hull planking. Extensive recording of the visible features and feeling by hand beneath the sludge at the bottom of the trench, however, enabled further understanding of the timbers (**Figures 17 and 18**).

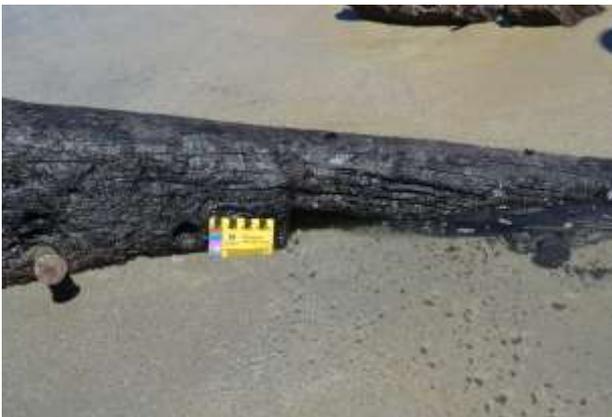
Figure 17: Close-up of construction features on deadwood

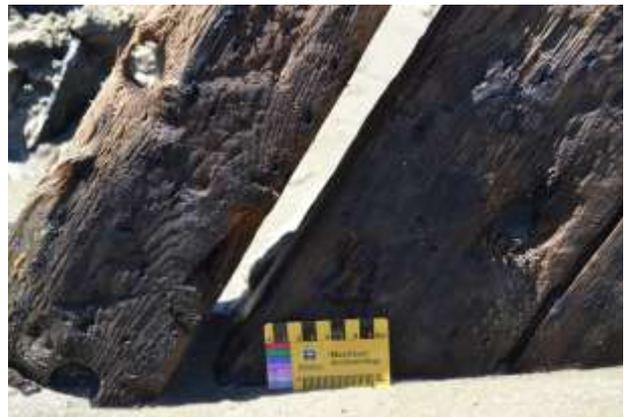
Figure 18: Close-up of planking construction

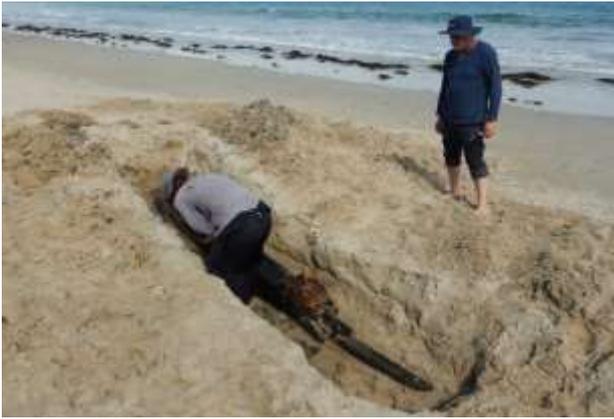
Figure 19: Site B—excavation underway on day 1

Site B was re-located during the metal detector survey. Although buried at the time, the shackle was clearly visible during previous site visits. Excavation of this site ran for two days and did not rely on a formal grid. The site is known to have uncovered and covered over the past few years, so sediment and stratigraphy recording was not essential. In addition, there was no apparent stratigraphy across the site—just beach sand. Instead, we followed the timbers as they were uncovered and maintained uniform trench walls around the structure (**Figures 19–20**).

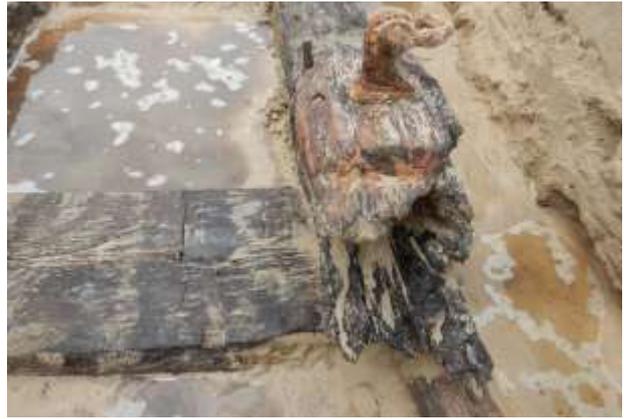
Figure 20: Site B—structure beneath the D-shackle

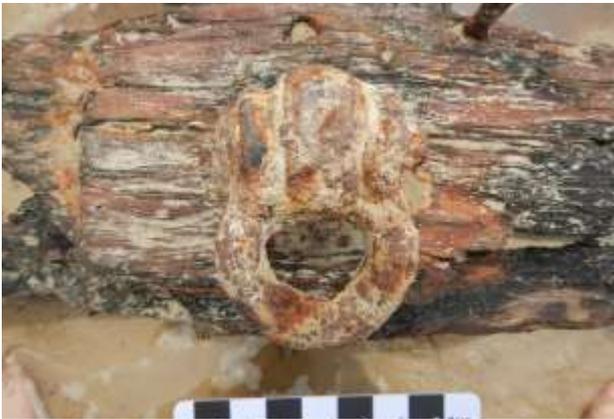
Figure 21: Plan view of D-shackle

The presence of the shackle and the way that it is fastened to the timbers indicates that the structure may be part of the deck structure, or at least related to rigging (**Figures 21 and 22**). This is part of current further historical research that aims to identify the structure and possibly what part of the *Amazon* it could be.

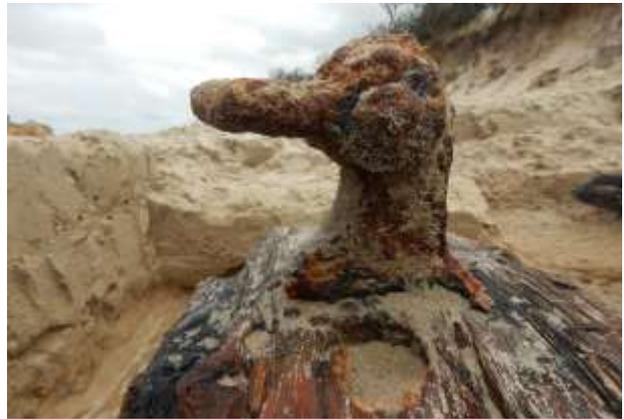
Figure 22: Profile view of D-shackle

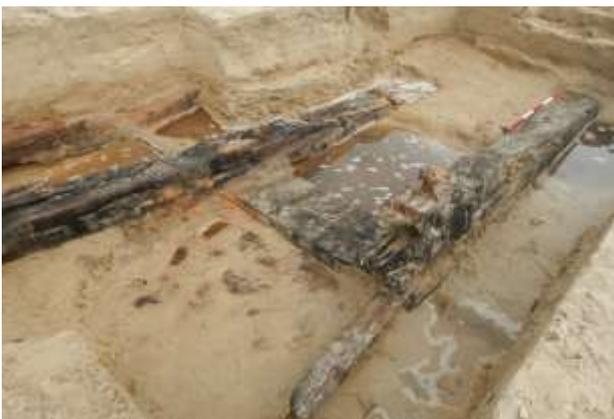
Figure 23: Site B—highlighting the way the timbers are stacked

The shackle is attached to a large timber (measuring 3.99m in length) with a mortise on the underside and notch on the exposed topside. The two larger ‘frame-like’ timbers are sturdy. Timber 1 measures 399cm in length and 28cm in thickness, timber 2 measures 430cm in length and 25cm in thickness (its eastern end appears to be broken). These two timbers sit parallel to each other and are joined together via a wide heavy timber (Timber 4) that is 44cm in width and 10cm in thickness (**Figures 23 and 25**).

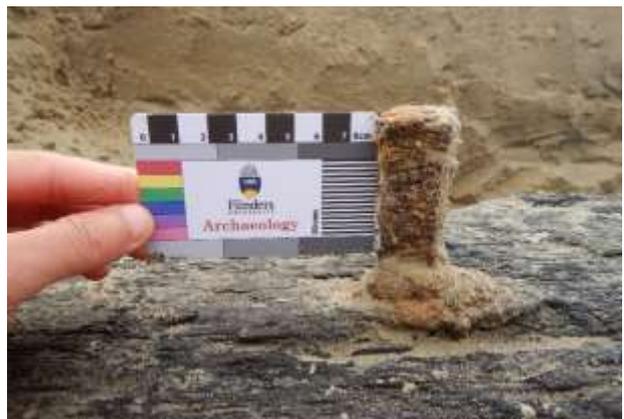
Figure 24: Example of a square fastener on Timber 1

On the second day, two more timbers were uncovered to the north of the known structure. A total of four timbers were documented during the Site B excavation. Each timber contained a combination of copper alloy square nails, iron bolts, iron concretions, treenail holes, and treenails (**Figure 24 and Table 4**).

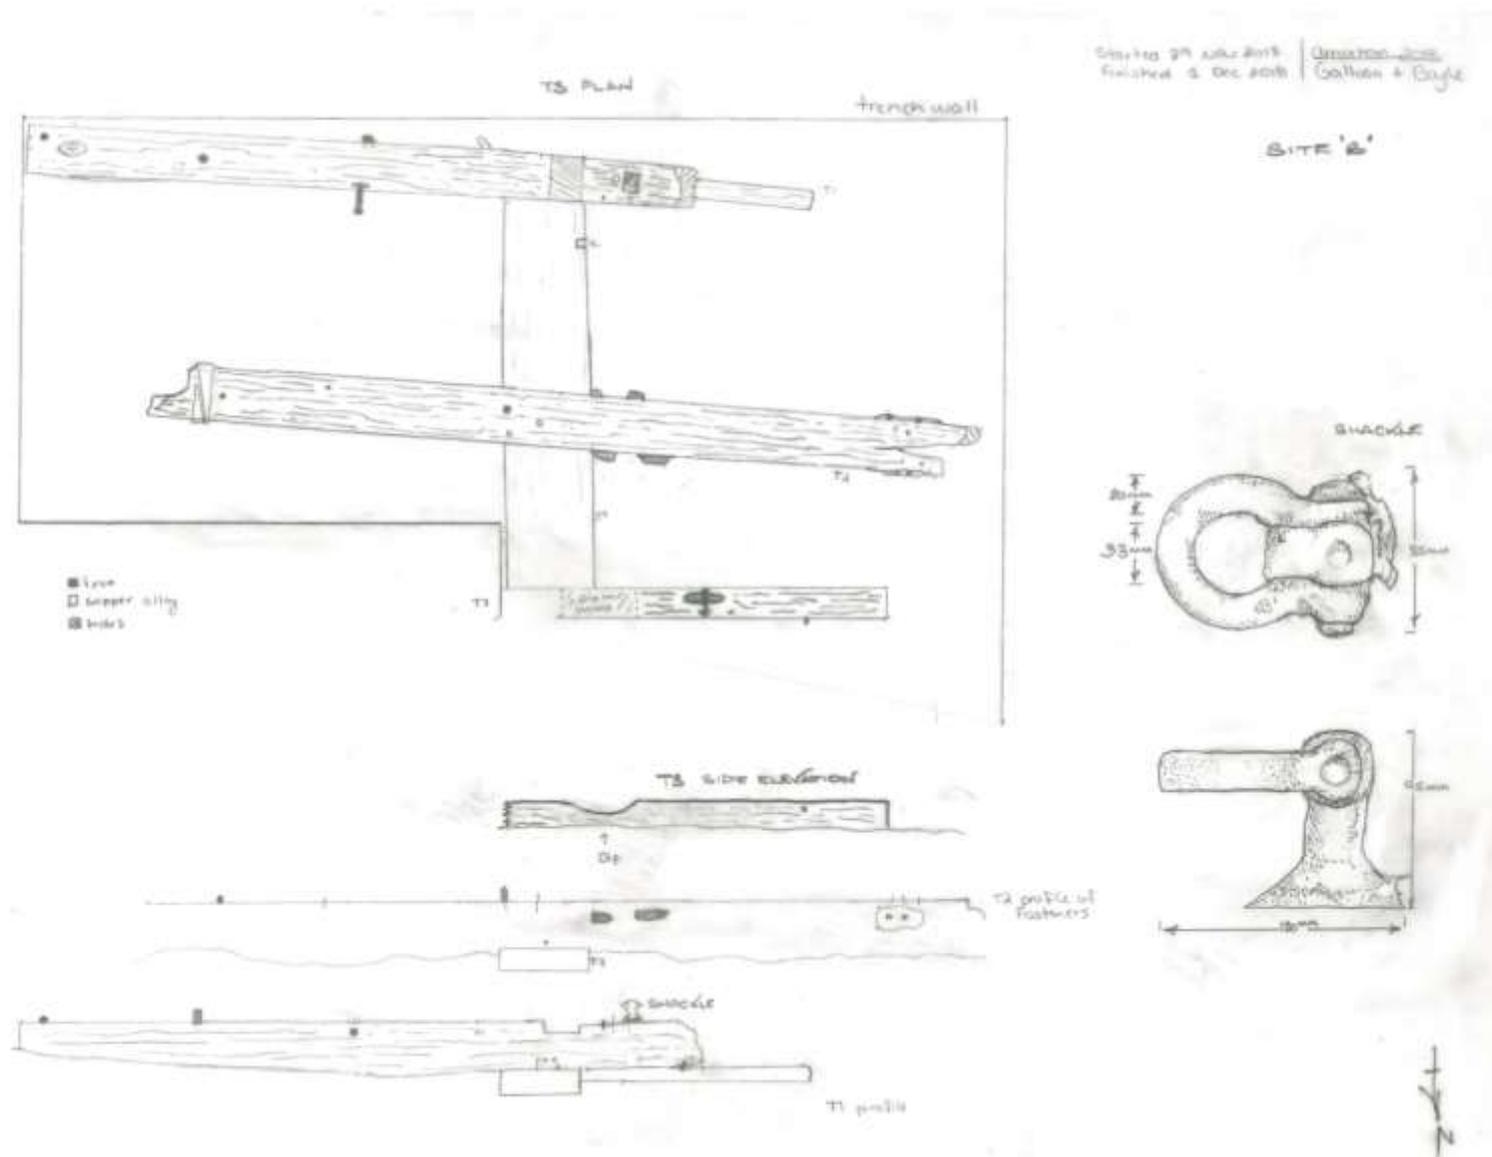
Figure 25: Scaled plan of Site B

Plan shows close-up representation of the d-shackle, profiles of the three main timbers and a plan view of the whole trench.

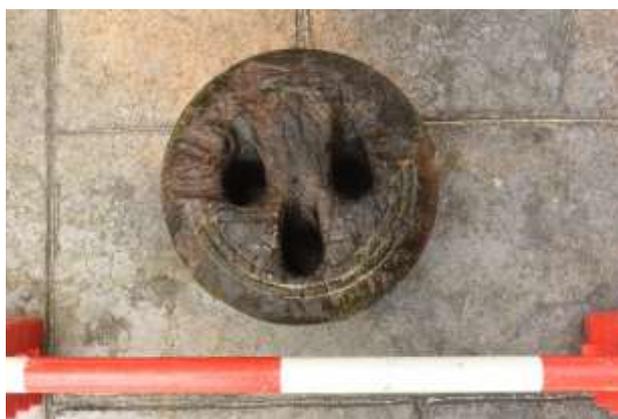
Figure 26: Artefact 23.00001—Deadeye.

During the fieldwork it became apparent that there were a select number of items in the possession of community members were unique and well-preserved. Consequently, we decided to accession four artefacts: the large deadeye (23.00001), a well-preserved example of copper sheathing (23.00011), small fairlead (23.00005) and a rope fragment with a leather binding (23.00006). these artefacts were assessed by Heritage Victoria staff in December 2018 and are currently awaiting conservation treatment for long-term storage.

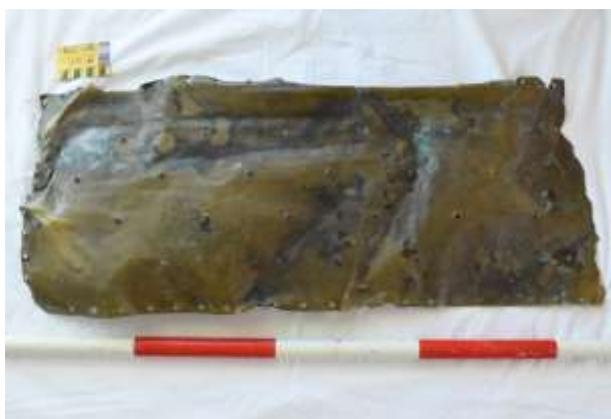
Figure 27: Artefact 23.00011—Copper sheathing.

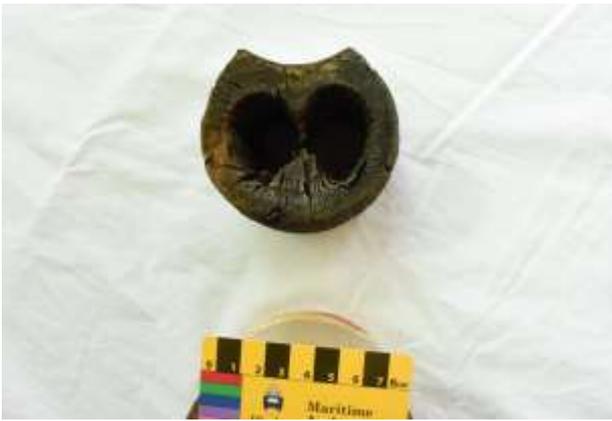
Figure 28: Artefact 23.00005—Fairlead.

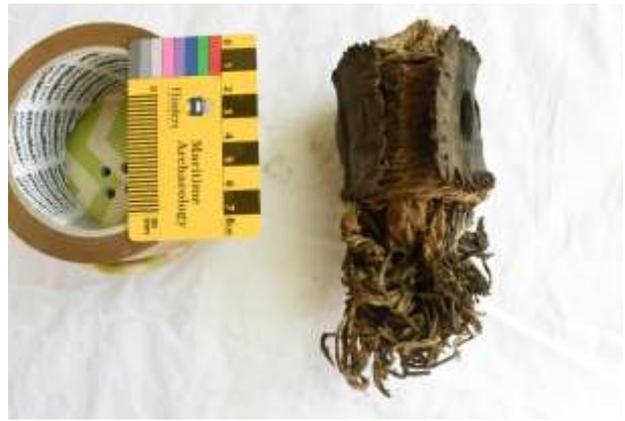
Figure 29: Artefact 23.00006—Rope and leather binding.

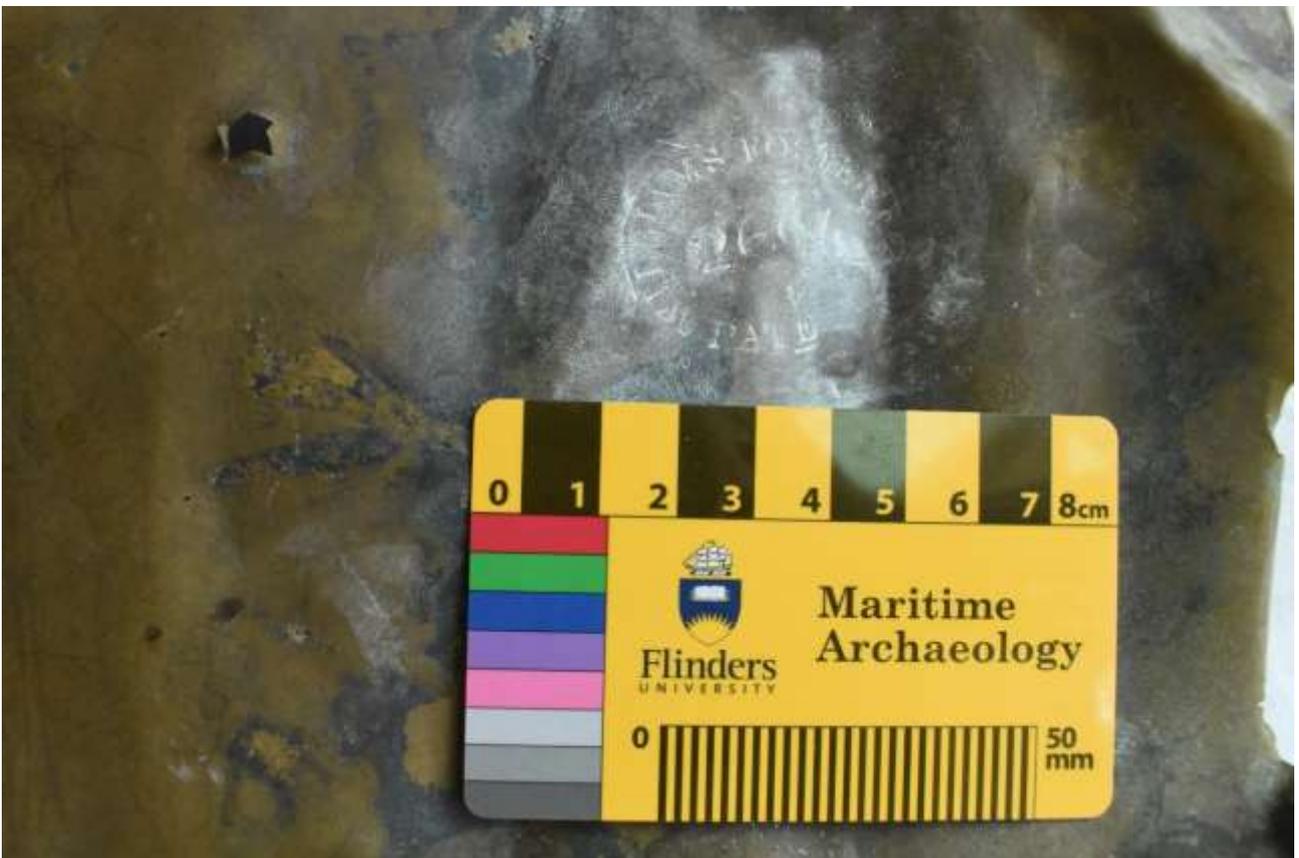
Figure 30: Makers stamp on copper sheathing.

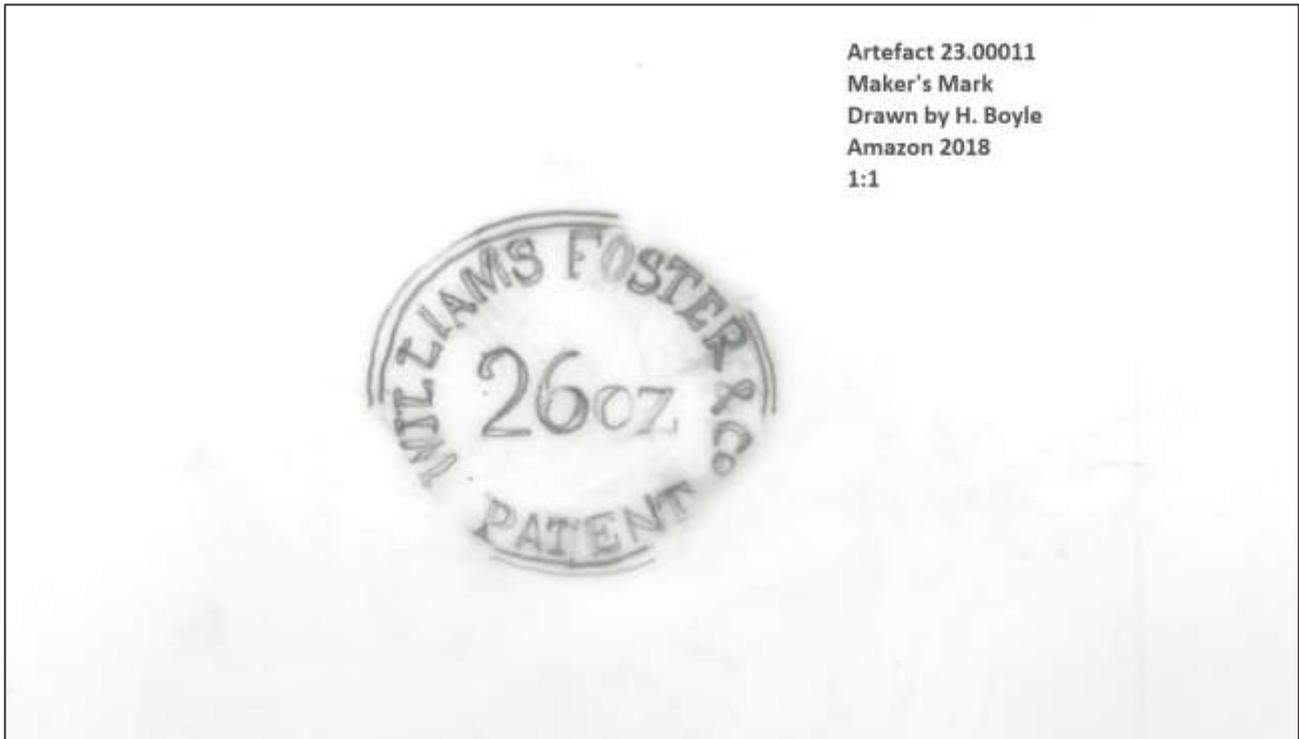
Figure 31: Artefact 23.00011—Copper Sheathing: drawn representation of the Maker's Mark.

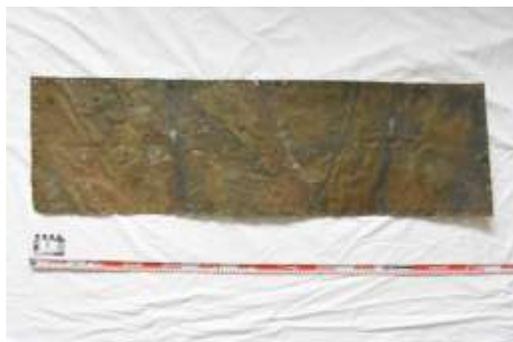
Description: Large rectangular sheet of copper sheathing. Square-copper tack marks approximately 6-8mm diameter, 35mm approximate distance from one hole to another. About 5mm distance from edge to perforated outline of tack marks. Slightly crumpled with multiple indentations. Tack marks aligned on a diagonal axis within tacked bordering.

Material: Metal, copper

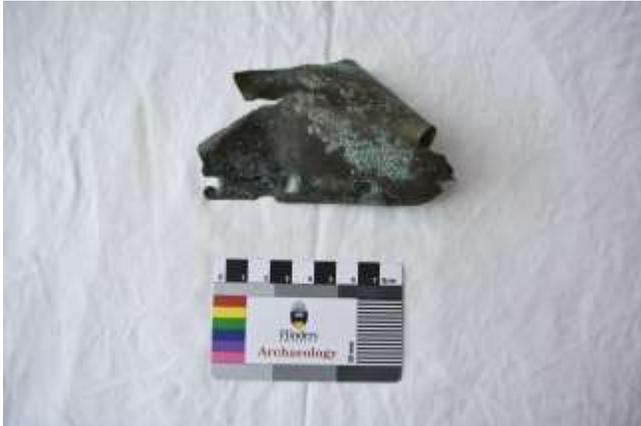
Description: Fragment of metal sheathing. Square perforation, approx. 5mm diameter, along edge. Bent. Very corroded. Large areas of patina visible.

Material: Metal, Copper

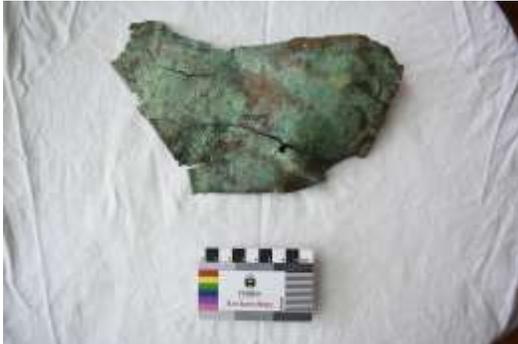
Description: Copper sheathing fragment of irregular shaping. Bent. One side folded. Patina largely present on one side.

Material: Metal, copper alloy

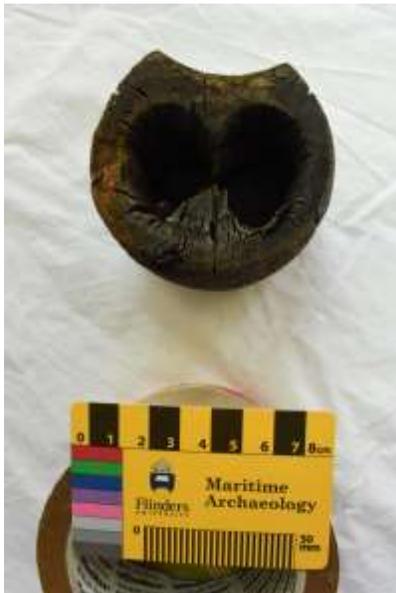
Description: Wooden fairlead with various cracks. Broken barrier between two large holes within face. Grooved indentation along height. Rigid indentation along center circumference extending from one end of groove to other groove end.

Material: Wood
Condition: Fair

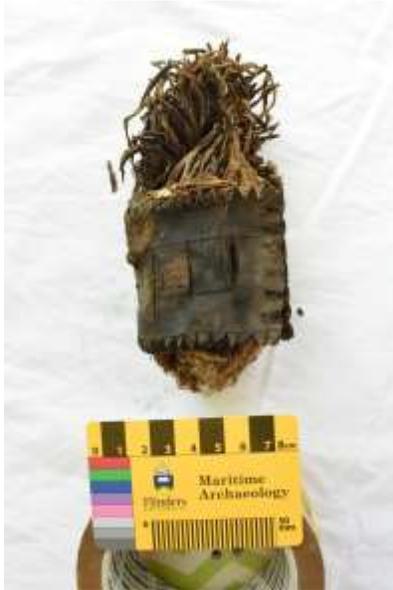
Description: Piece of large rope part of standing rigging. Section has been wormed, seized and parcelled. One end heavily frayed. Broken leather parcelling.

Material: Rope- unknown fiber. Leather parcelling.
Condition: Fragile. Most parts missing

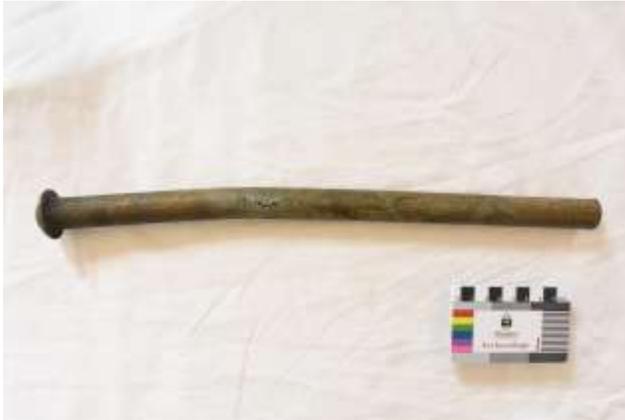
Description: Long copper bolt with head. Slight bend. Patina presence.

Material: Metal, copper alloy

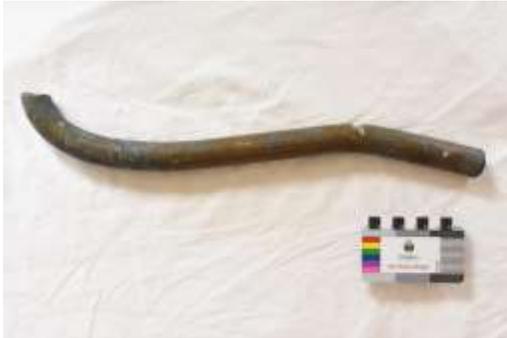
Description: Long copper bolt, bent. Patina present. Two bends-- Exposed bolt opening on crack near base, and smoothed curvature towards head.

Material: Metal, copper alloy

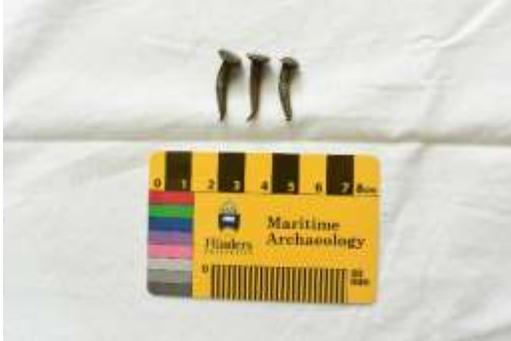
Description: Three small bent copper tacks. All bent at base head and tip. Two tacks sharply bent at tip, one with U-bend visible.

Material: Metal, copper alloy

Condition: Great-- intact.

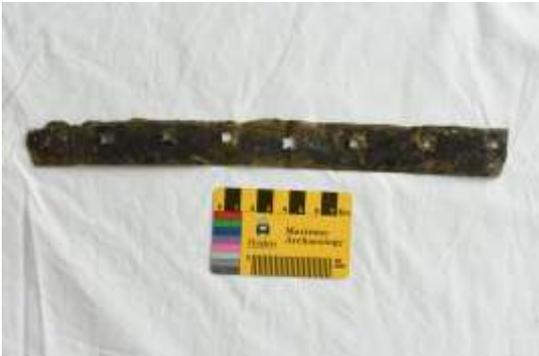
Description: Corroded copper metal strip with jagged, square perforations. One length displays clean straight-lined edge. Other side length is corroded and jagged. Fragmented.

Material: Metal, copper alloy

Condition: Fair

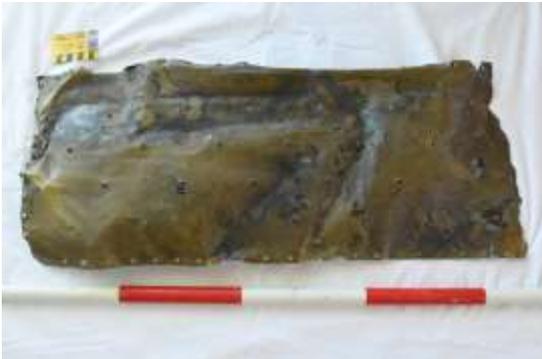
Description: Large metal copper sheet with hole perforations alongside edge and middle. Corroded. Patina present. Displays jagged edges.

Material: Metal, copper alloy

Condition: Fair

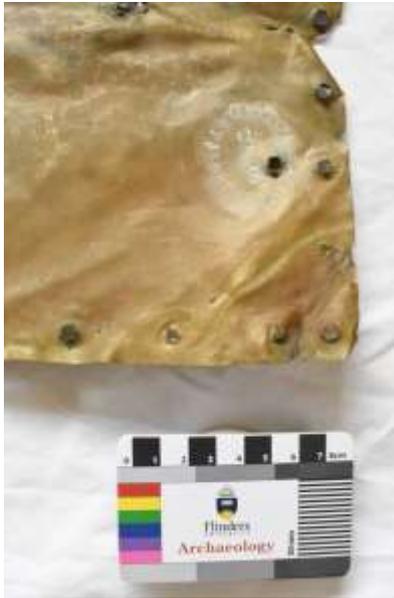
Description: Segment of large metal copper sheet. Hole perforations alongside edges. Diagonally- spaced perforations present within face. Severely crumpled on single edge width. Tack included. Corroded; patina present. Maker's mark, "Williams Foster," present.

Material: Metal, copper alloy
Good

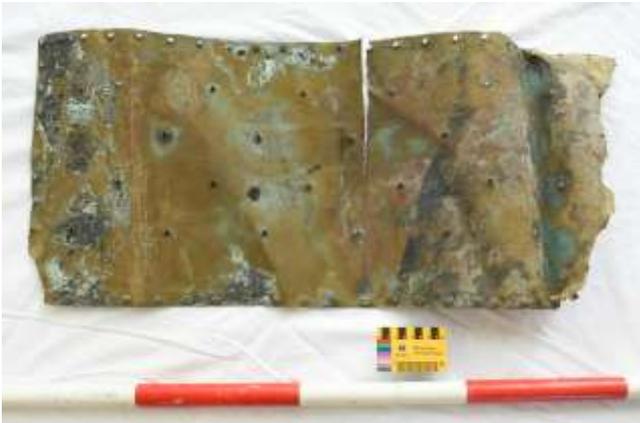
Description: Section of copper sheet. Straightened edges on both lengths and one width. Other width is jagged. Large crack formed near middle of section. Hole perforations alongside edging. Diagonal- lining perforations on face. Corroded, visible patina.

Material: Metal, copper alloy

Condition: Acceptable

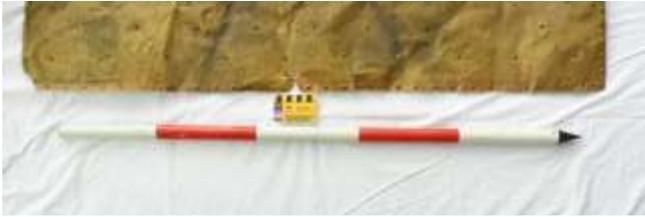
Description: Large metal sheet with straight-lined, intact edges. Perforations alongside edges and within face in a diagonally-line manner. Gold surface coloring. Various dents along face. Single jagged corner edge. Minor cracks on face.

Material: Metal, copper alloy

Condition: Excellent

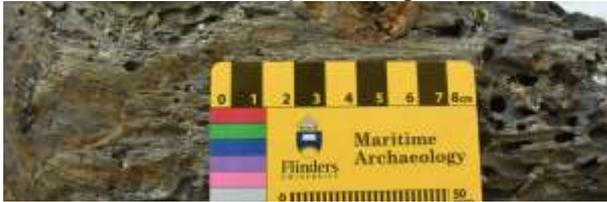
Description: Wooden frame chunk, timber. Trunnell and spike hole present. Very heavily massacred by teredo worms.

Material: Wooden, timber

Condition: Poor

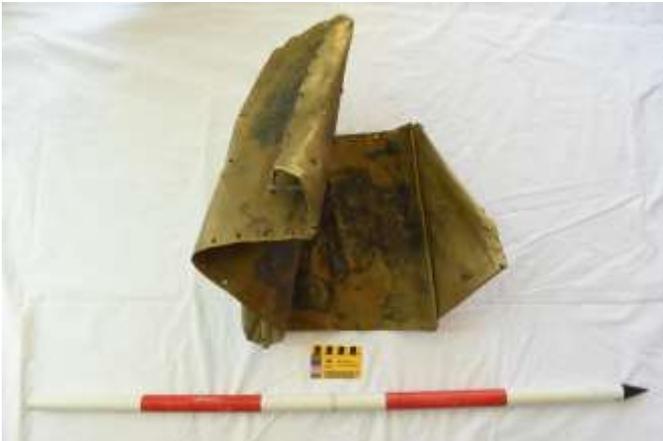
Description: Full copper sheet that has been sharply folded to various degrees. Corroded. Perforations alongside edge and face.

Material: Metal, copper alloy

Condition: Poor

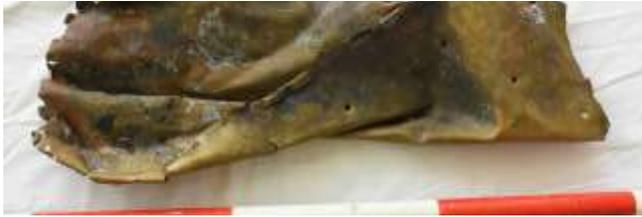
Description: Fragment metal sheathing. Various hole perforations on face. Jagged edges. Crumpled piece. Folded.

Material: Metal, copper alloy

Condition: Poor

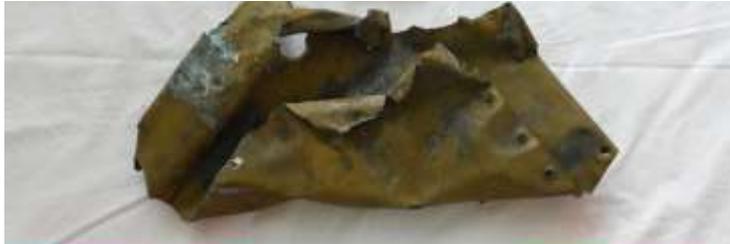
Description: Folded metal copper sheet section. Jagged edges. Perforations alongside one edge and face. Sharpy bent. Torn fragment.

Material: Metal, copper alloy

Condition: Poor

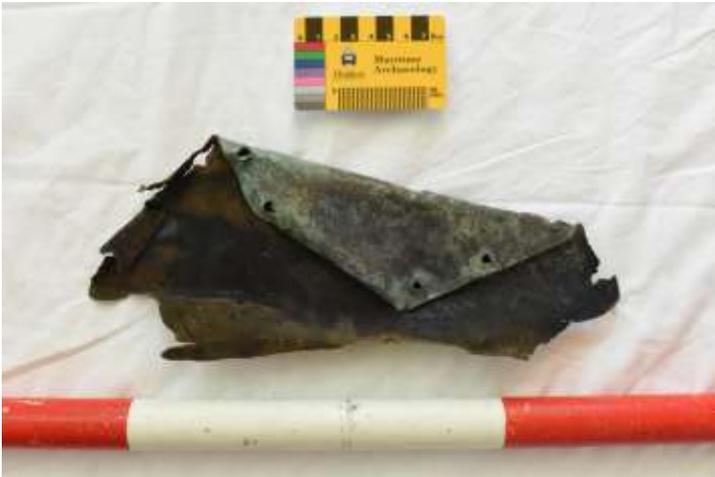
Description: Fragment copper piece. Bent. Jagged sharp edges. Small, and torn. Corrosion, patina present.

Material: Metal, copper alloy

Condition: Poor

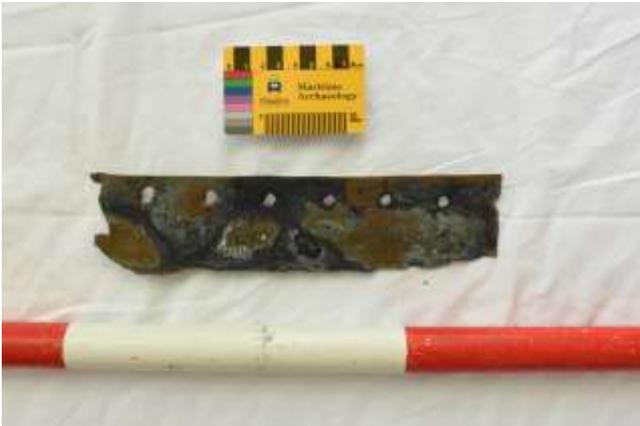
Description: Small, corroded copper strip. Perforations alongside one edge. Straight-lined edging on single length- side and width- side. Other length and width edge jagged. Patina present.

Material: Metal, copper alloy

Condition: Acceptable

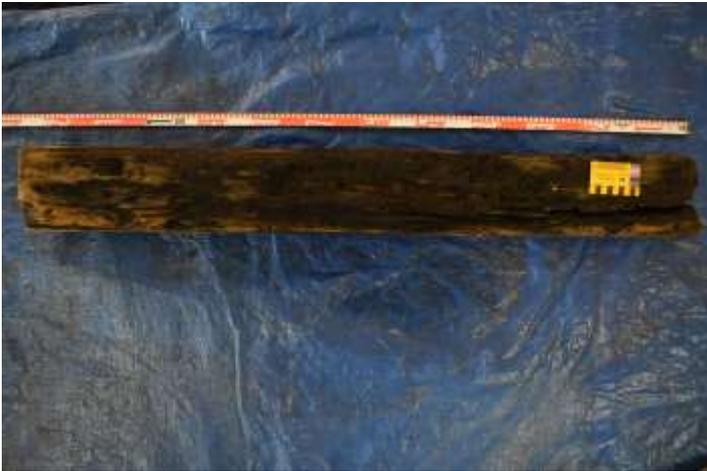
Description: Large wet timber with tree nails.

Material: Wood

Condition: Poor

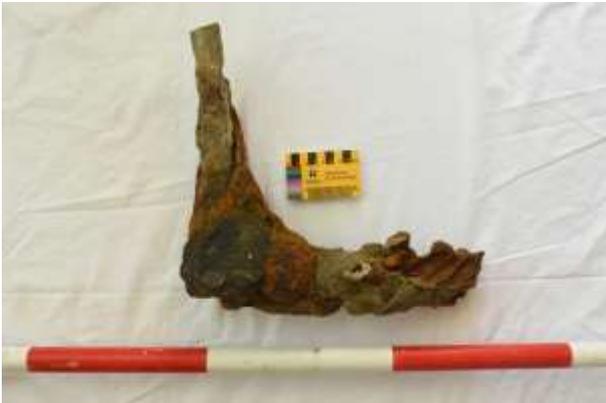
Description: Heavy iron rigging concretion with rope imprint. Much corrosion. Orange discoloration on surface. Triangular shape.

Material: Metal, copper alloy

Condition: Acceptable

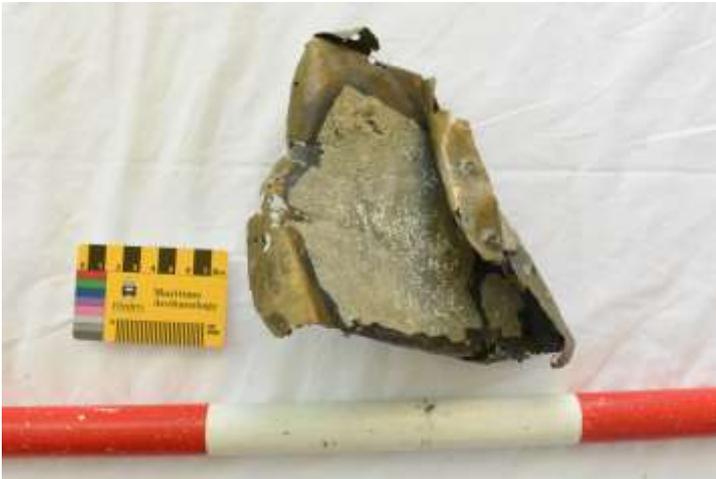
Description: Copper metal fragment, bent in triangle formation. Perforations along single edge. Sharp, jagged exterior edging on others. Heavy corrosion.

Material: Metal, copper alloy

Condition: Poor
