The Amazon (1863) Shipwreck Project

25 November - 5 December 2018

January 2019

Project Report

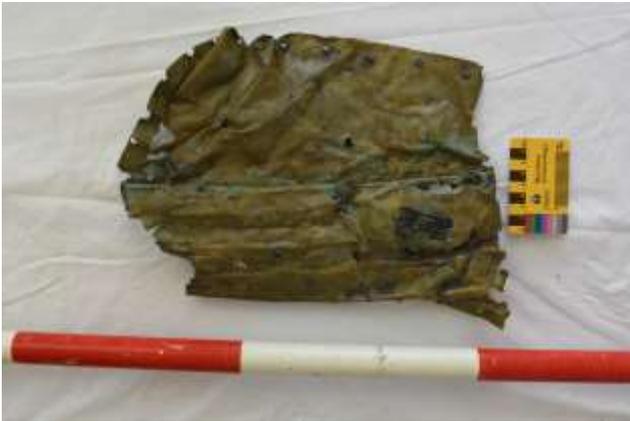
Description: Fragmented copper metal piece from sheet. Hole perforations alongside interior or single edge. Other edges display sharpened, jagged tearing. Crumpled middle. Hole perforations present on face. Heavily corrode; visible patina.

Material: Metal, copper alloy

Condition: Poor

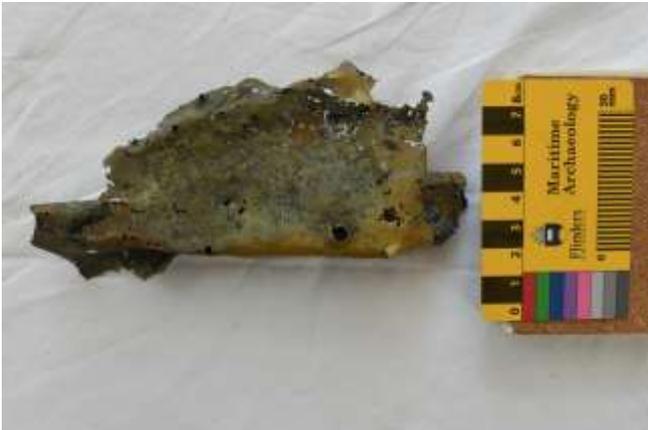
Description: Small, fragmented piece of copper sheathing. Heavy corrosion; large patina visible on surface. Crumpled.

Material: Metal, copper alloy

Condition: Poor

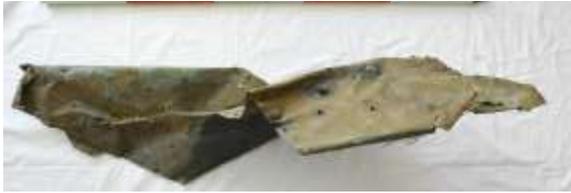
Description: Full metal copper sheet, bent and folded with multiple hole perforations. Perforations punctured within edging of sheet and on face. Corroded; patina present.

Material: Metal, copper alloy

Condition: Poor

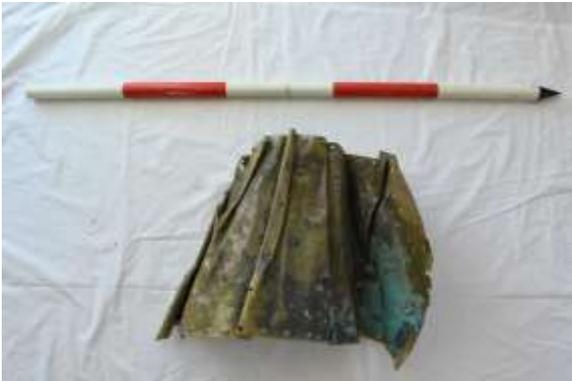
Description: Bent metal copper fragmented section with hole perforations alongside interior edges and face. Heavily corroded; patine visible on surface.

Material: Metal, copper alloy

Condition: Poor
